Loss / Near Loss (L/NL)

Loss/Near Loss ID : 23624

Short Description : Natural gas routed to T-397

TAPROOT DESCRIPTION: Natural gas was inadvertently routed to T-397 on October 8, 2011 at 16h37 when flow reversed from the headspace of V-153A/B at the SDA. This resulted in a hazardous condition as natural gas vented via the two breather valves and pressure relief door on the roof of T-397. Attempts to mitigate the risks included cordoning off the tank and introducing a nitrogen purge to the head space. Efforts to locate the source of the natural gas was complicated by startup activity on the TKC and shutdown activity on RLOP and the SDA. The source of the natural gas was identified and isolated on October 13, 08h04. The consequence of this incident was a Title V deviation for exceeding the vapor pressure limit of 0.5 psia for a tank in unregulated service BAAQMD Reg 8-5-117 and Permit Condition 20764. The refinery also received two odor complaints from the community. It was determined that the event met the requirements of a Tier I Loss of Containment (LOC) incident.

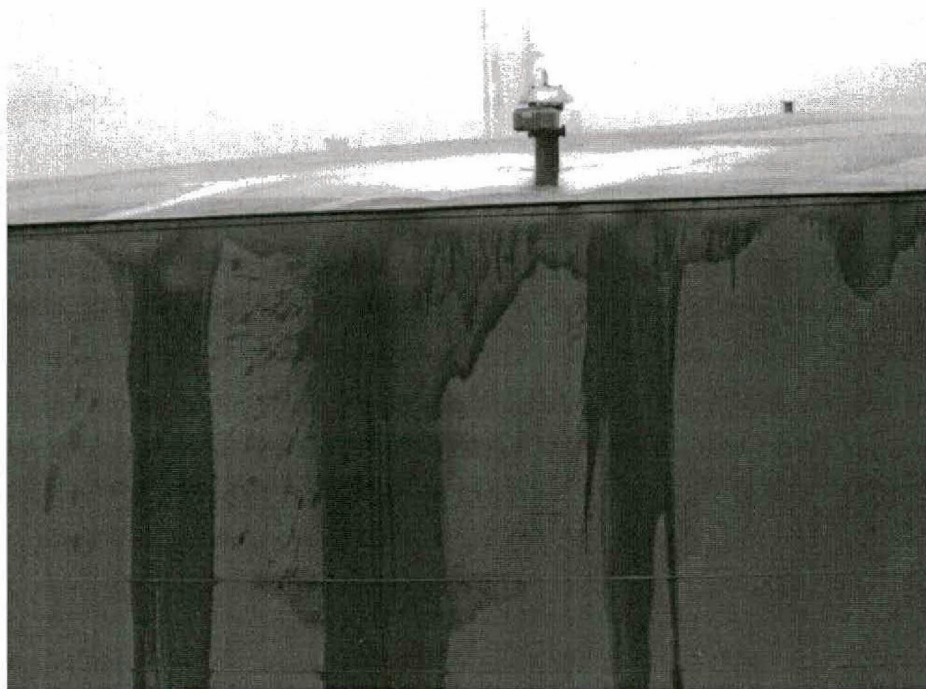
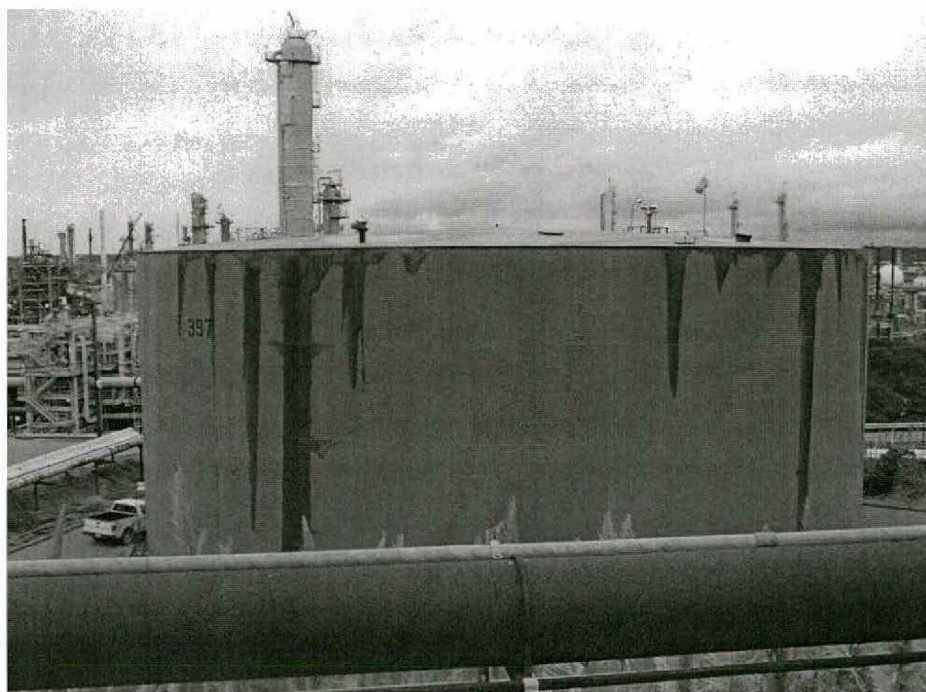
Appendix 3 : T-397 pictures

Loss/Near Loss Description : INITIAL DESCRIPTION: At 3:00 PM the operator was making rounds when he spotted the pressure valves on the tank roof burping liquid on the roof.

Gas is to believed to commence entering T-397 at ~16h52 October 8 as indicated by the fluctuating level in T-397. LCO is observed to be dripping from the roof of T-397 on October 10 at ~14h00 by the field operator. A noticeable odor of gas is reported around the B&S area at this time. Troubleshooting efforts are initiated refinery wide that evening to determine the source of the light liquid or gas that had been routed to T-397. The unusual and dynamic posture of plants over the preceding days complicate the troubleshooting effort : RLOP had commenced turnaround activity on October 3, TKC had started up on October 8 and the SDA had shutdown on October 2. Trends and lineups on these plants and the FCC were analyzed in the search for light material that had been routed to T-397.

On Wednesday October 12 it is noted the venting on T-397 has not subsided. A liquid sample of the tank contents indicates the presence of light hydrocarbon such as natural gas. A sample of the headspace in T-397 confirms the presence of natural gas and an emergency response plan is subsequently prepared. An infrared camera scan of the roof of T-397 indicates that the natural gas is venting from three locations : the two breather valves and the pressure relief door. A nitrogen purge is introduced at the 35’ level of T-397 to ensure the tank head space stays oxygen free. A Title V deviation was submitted for exceeding the vapor pressure limit of 0.5 psia for tanks in unregulated service BAAQMD Reg 8-5-117 and Permit Condition 20764. The refinery received two odor complaints from the community on this day. It was determined that the event met the requirements of a tier 1 loss of containment incident.

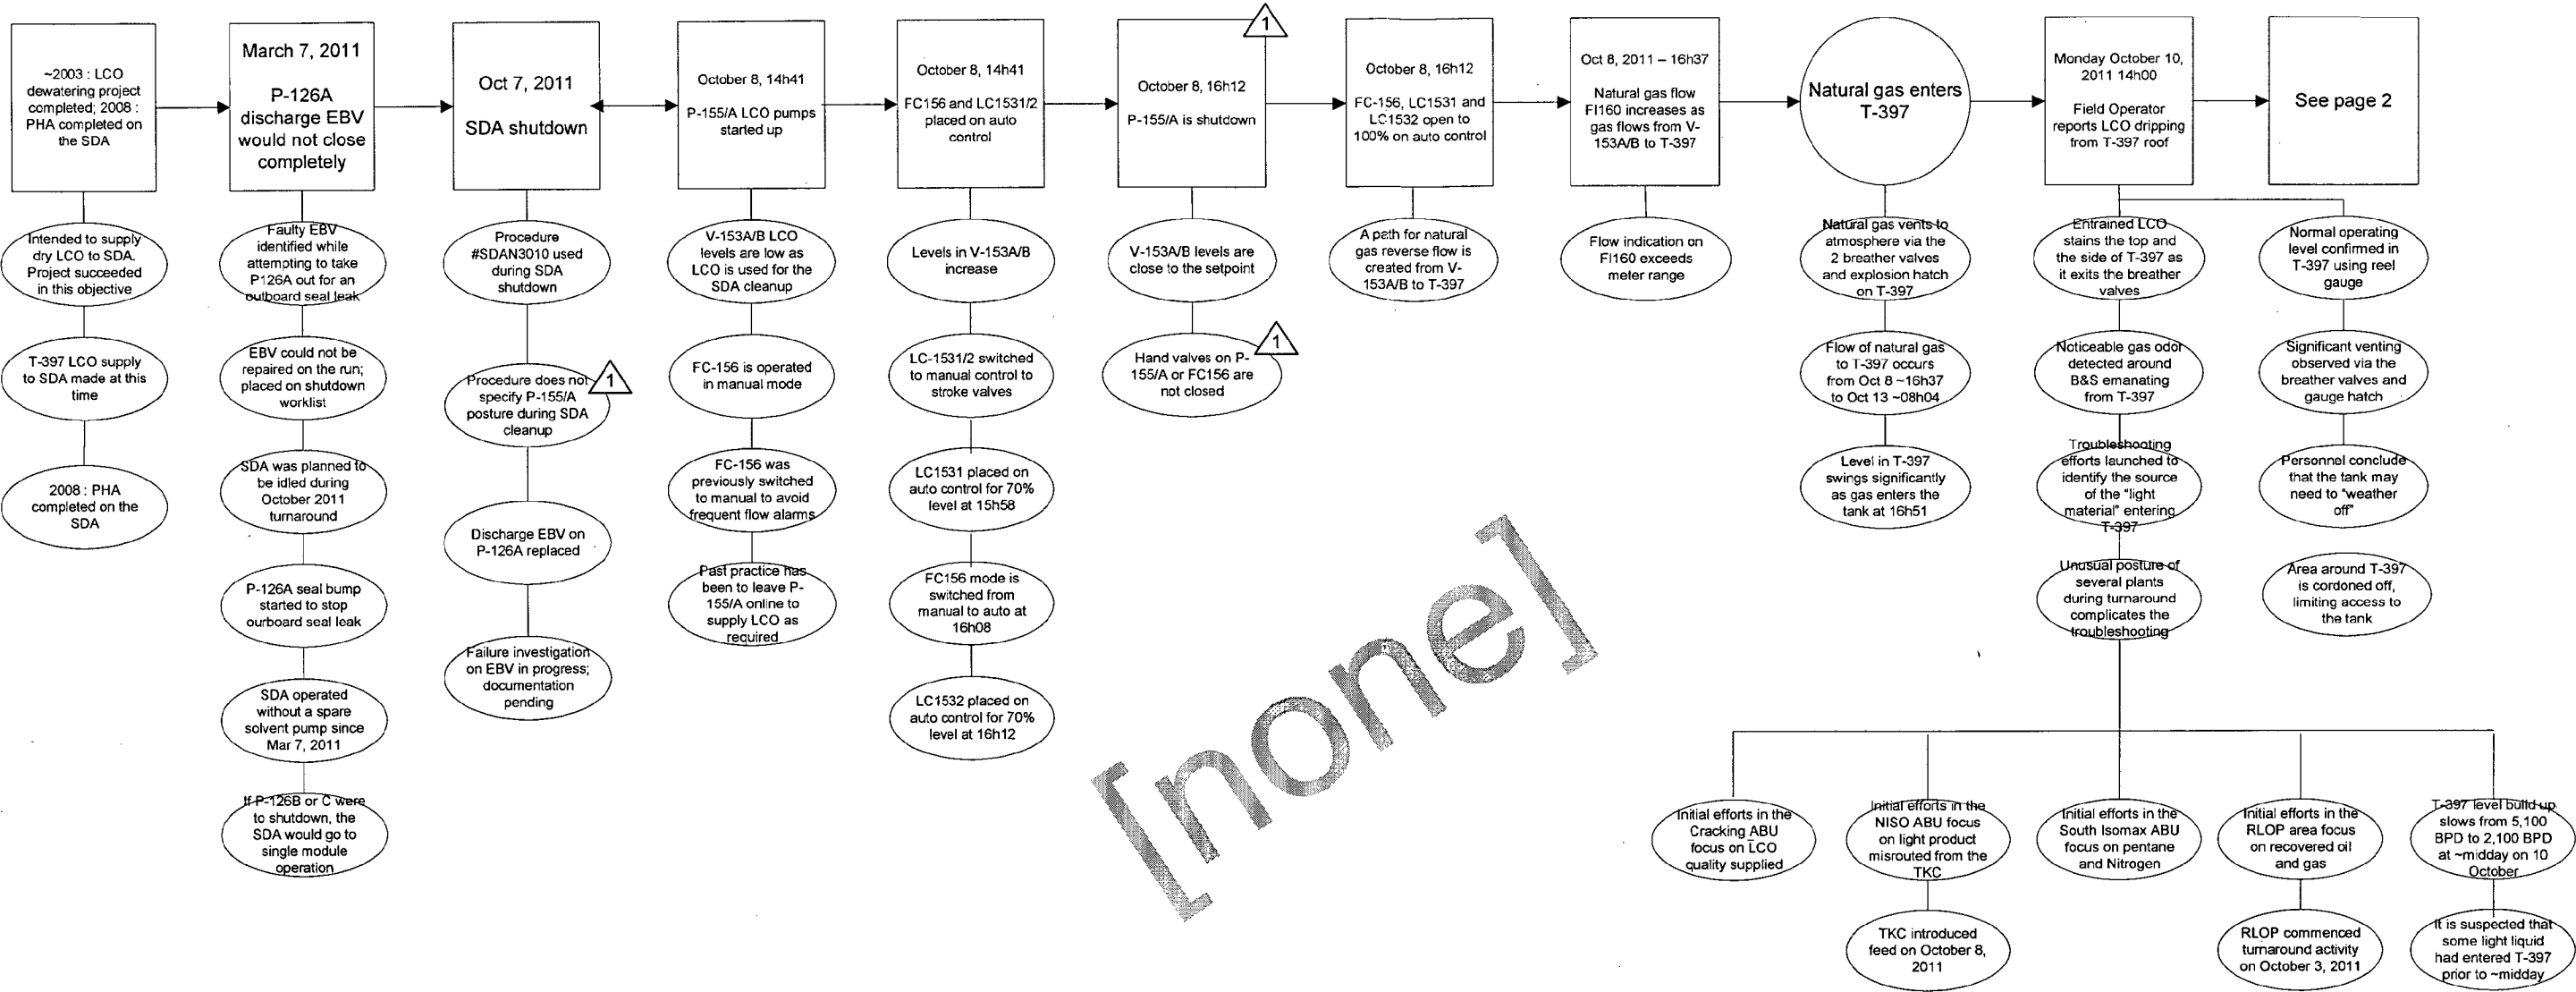
Events and Causal Factors Chart
Natural Gas enters T-397 – IMPACT ERM
#23624

Natural gas was inadvertently routed to T-397 on October 8, 2011 at 16h37 when flow reversed from the headspace of V-153A/B at the SDA. This resulted in a hazardous condition as natural gas vented via the two breather valves and pressure relief door on the roof of T-397. Attempts to mitigate the risks included cordoning off the tank and introducing a nitrogen purge to the head space. Efforts to locate the source of the natural gas was complicated by startup activity on the TKC and shutdown activity on RLOP and the SDA. The source of the natural gas was identified and isolated on October 13, 08h04. The consequence of this incident was a Title V deviation for exceeding the vapor pressure limit of 0.5 psia for a tank in unregulated service BAAQMD Reg 8-5-117 and Permit Condition 20764. The refinery also received two odor complaints from the community. It was determined that the event met the requirements of a tier 1 loss of containment incident.
